Development Policies and Practices Affecting Habitat *for* Anadromous Fish

**San Francisquito Creek Watershed, Santa Clara and
San Mateo Counties, California**

Prepared for San Francisquito Watershed Council

December 2005

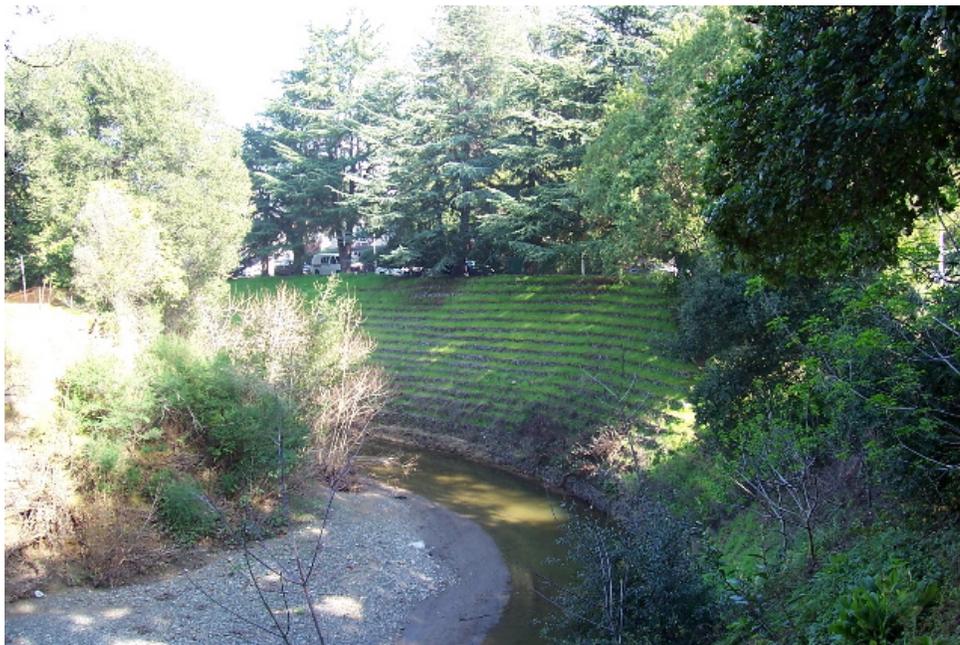
also common. Sacked concrete and gabions may be covered with an herbaceous layer of vegetation that does not add much to bank stability (Figure 2).

Figure 2. Gabion bank protection on San Francisquito Creek, Palo Alto. Bank protection is variable and interspersed with natural channel throughout the watershed on the main stem and tributaries.

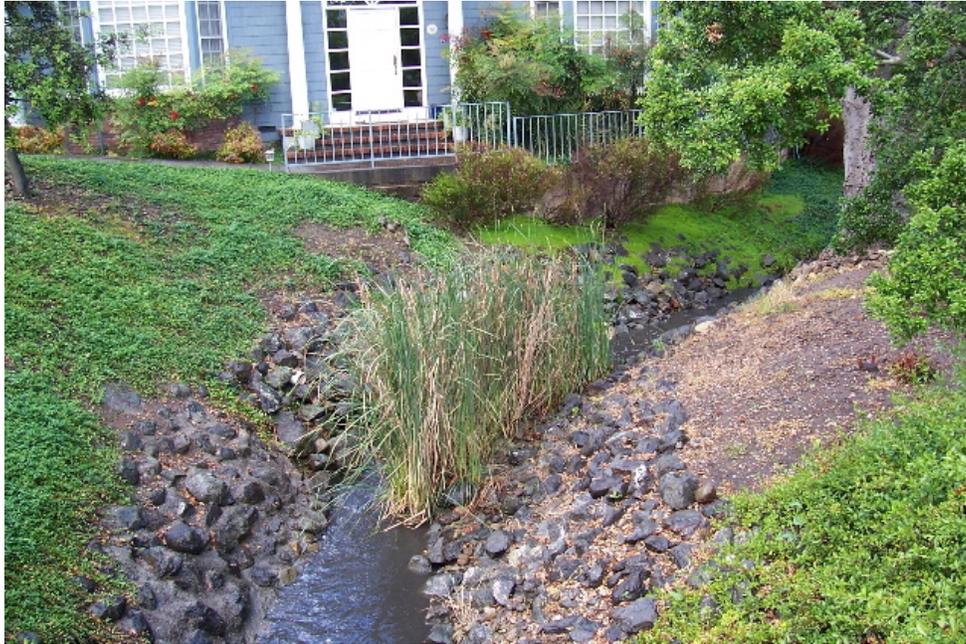
Activity 1 may have been installed by a landowner. It is uncertain if a permit was required or obtained (Figure 3). Activity 2 involved hardening an intermittent swale to prevent erosion and facilitate installation of roads and homes in a subdivision (Figure 4). The swale was armored upstream and downstream of a culvert with small rock and concrete and the crossing was constructed to act as a debris basin in case of a debris flow from unstable areas upslope. This activity was undertaken as part of the subdivision and was subject to environmental review.

Figure 3. Bank stabilization installed to protect single-family residence, Menlo Park (Activity 1).

No direct impacts on fish habitat either at or downstream from the sites were apparent with either of these projects; however, cumulative impacts from such projects would include losses in instream habitat and potential for downstream erosion and sedimentation caused by increases in stream power.

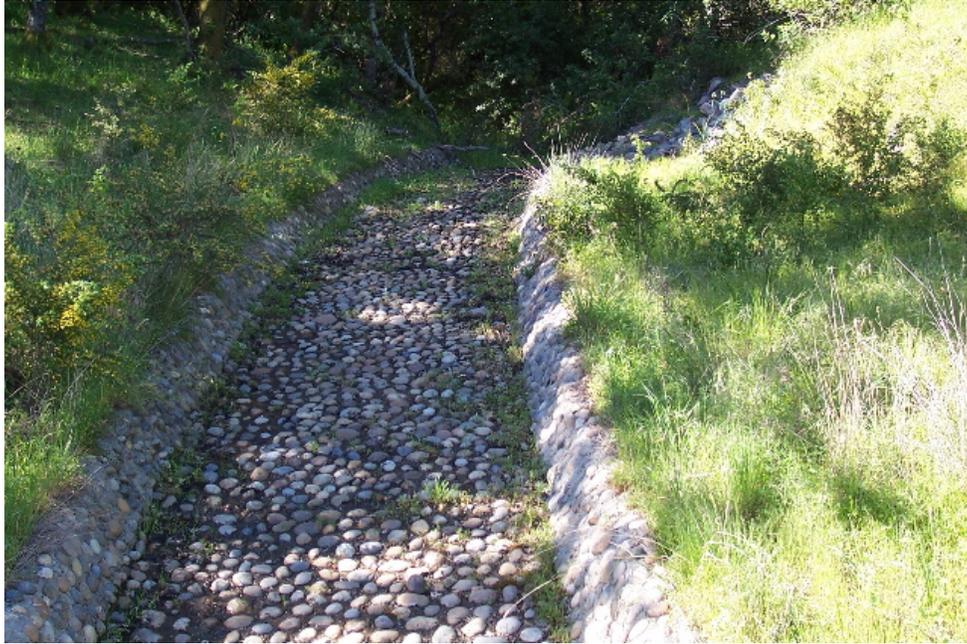
Figure 4. Rock-lined swale, Blue Oaks subdivision, Portola Valley.

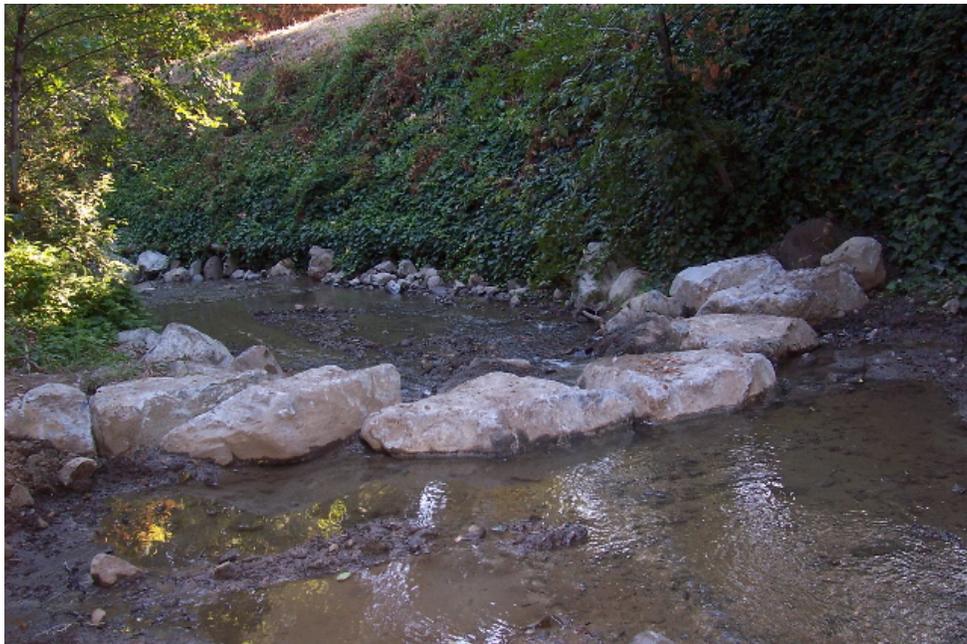
Activity 3 was the installation of five rock vortex weirs in a reach where existing bank stabilization structures were failing (Figure 5). Boulders were keyed in without use of mortar or cables and some weirs created downstream scour pools. Activity 4 involved installation of a cross vane weir as a mitigation for unintended impacts associated with installation of gabion

Figure 5. One of five weirs installed to reduce bank erosion and incision on Saratoga Creek. This type of treatment is being applied by SCVWD as an alternative to typical bank stabilization approaches.

baskets throughout the reach in 1998. Impacts from the earlier project included a permanent reduction in riparian vegetation (although re-vegetation was done downstream) and incision. If the rock weir installation is successful, the incision may be reversed. Activity 5 was the installation of four cross vane weirs secured with mortar. Notches were made in the weirs to allow fish passage. Upstream deposition may have occurred and detrimentally affected instream habitat.

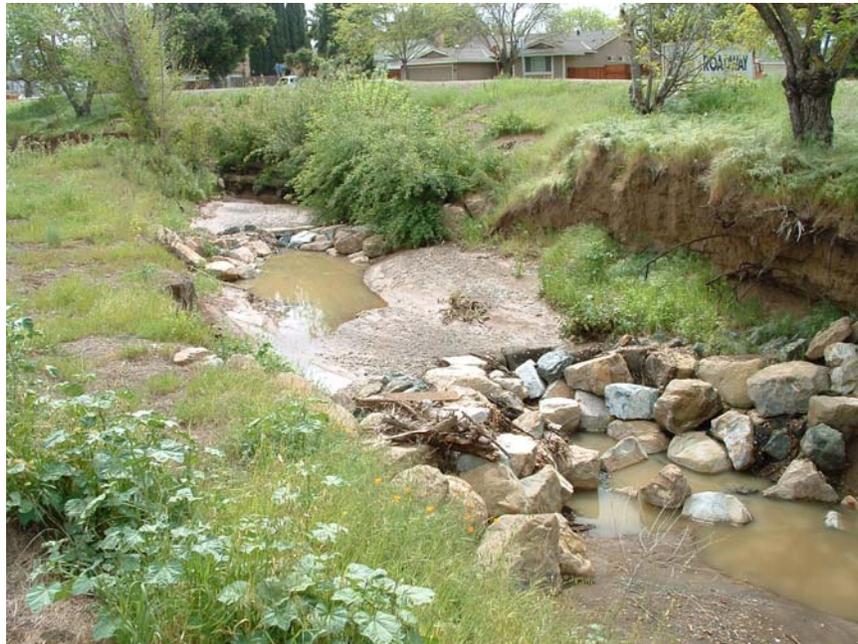
SCVWD commonly uses weirs as an alternative to conventional bank protection. Figure 6 illustrates a successful project of this type undertaken by SCVWD on Thompson Creek. Observations indicate that they perform well for grade control upstream of the weir and can reduce downstream bank scour. They need to be closely spaced to minimize downstream scour (J. Owens, personal communication). They also seem to cause some localized bank scour upstream, reinforcing a need for measures to prevent the creek from migrating around the structure(s) (J. Owens, personal communication).

Figure 6. Cross vane weirs promoting deposition and channel narrowing, Thompson Creek.
This SCVWD project is about three years old (photograph courtesy of J. Owens).

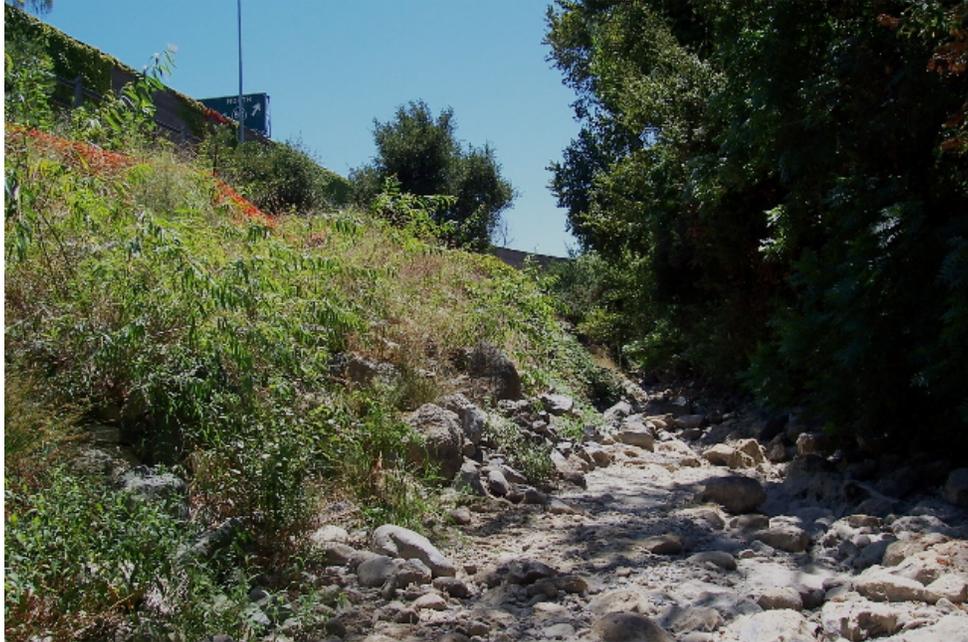
Activity 6 entailed removing a failed section of sacked concrete, laying back banks, installing large rock, and re-vegetating the slope to protect a nearby state highway. This project improved instream habitat by reducing the amount of hardened bank and restoring a natural bank angle. It also increased vegetation in the riparian area (Figure 7).

Figure 7. Bank stabilization and re-vegetation project applied to failing freeway embankment, Stevens Creek.

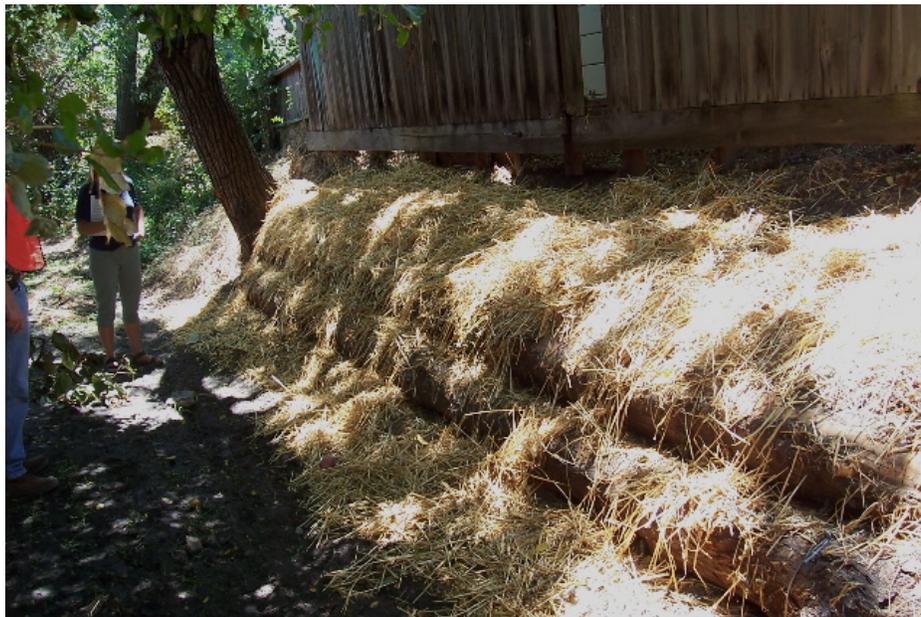
Activity 7 was the installation of two large logs to shore up an eroding section of creek bank within 10 feet of a private home. The logs should stabilize a large tree that might have been undermined in future high flows. Although the treatment avoided permanent hardened surfaces and may provide some cover for aquatic habitat, the logs may deflect flow and energy and cause bank erosion downstream (Figure 8).

Figure 8. Log installation to prevent bank erosion, Permanente Creek. SCVWD uses prescriptive guidelines for all projects involving placement of large wood in streams.

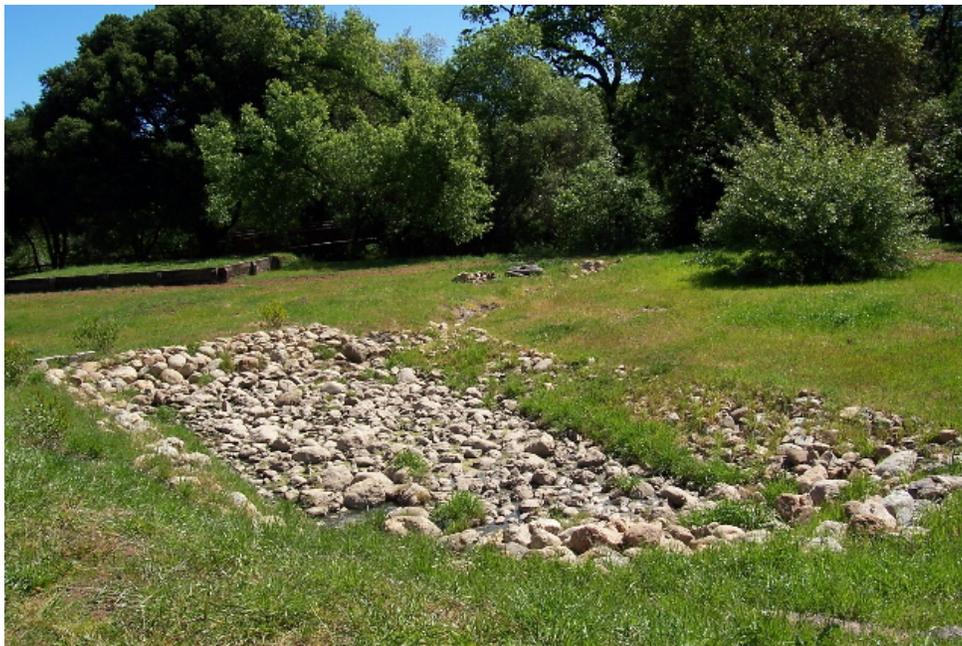
Figure 9. Rock-lined detention basin and drain, Los Trancos Creek, Portola Valley. This type of storm water management practice is commonly applied to new developments in the watershed by all jurisdictions. It is effective in reducing impacts on peak flows as well as reducing non-point source pollution.

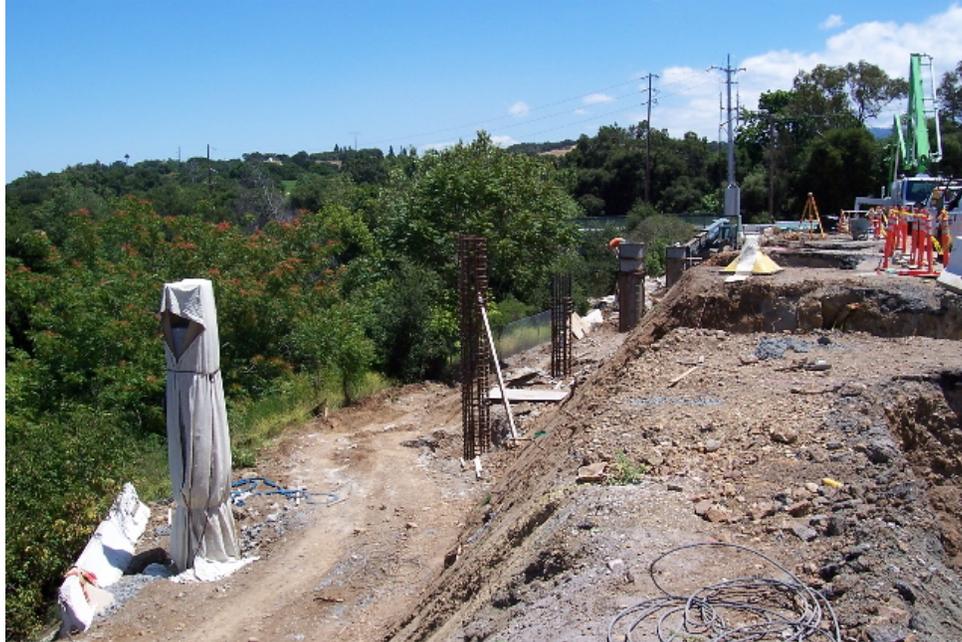
Figure 10. Bridge expansion project on San Francisquito Creek, Junipero Serra Boulevard. The project entirely avoided the riparian zone. Extensive erosion control measures were applied at the periphery of the excavated area.

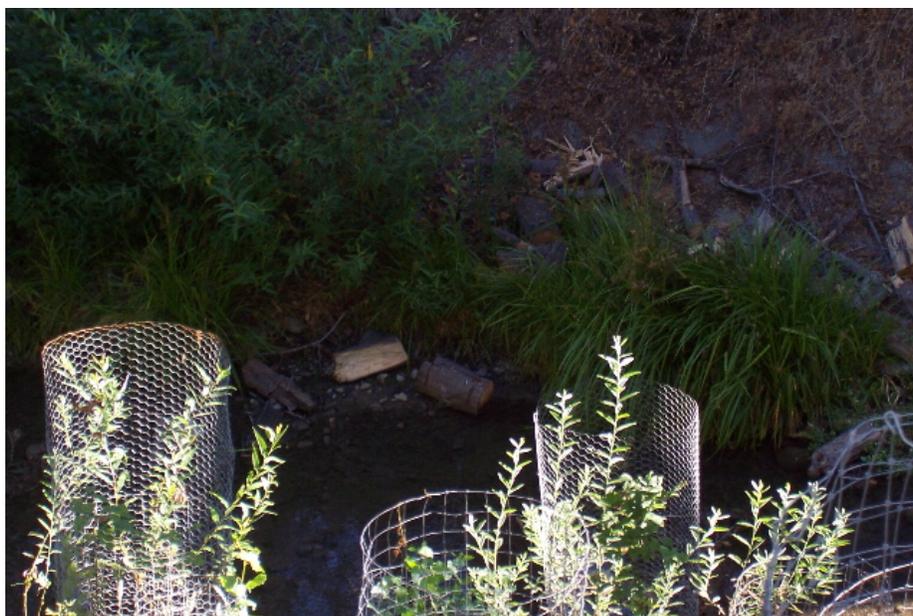
At Activity 21, a dead tree that had fallen into the creek was cut into two-foot lengths and left on the banks by SCVWD staff (Figure 11). This practice occurs in cases where trees may obstruct flows, cause erosion or pose a hazard. On creeks with anadromous salmonids under SCVWD jurisdiction (not Saratoga Creek) removal of large wood from the stream must be compensated for by placement of wood at another location on a 1:1 basis (B. Springer, personal communication).

Figure 11. Woody debris management, Calabasas Creek.
 Under SCVWD practices, large pieces of wood that fall into the stream or trees whose failure is imminent are cut into smaller pieces and either left on the banks or in the stream. Other jurisdictions probably use the same practices as the need arises. Note compensatory tree planting required in conjunction with channel work upstream.

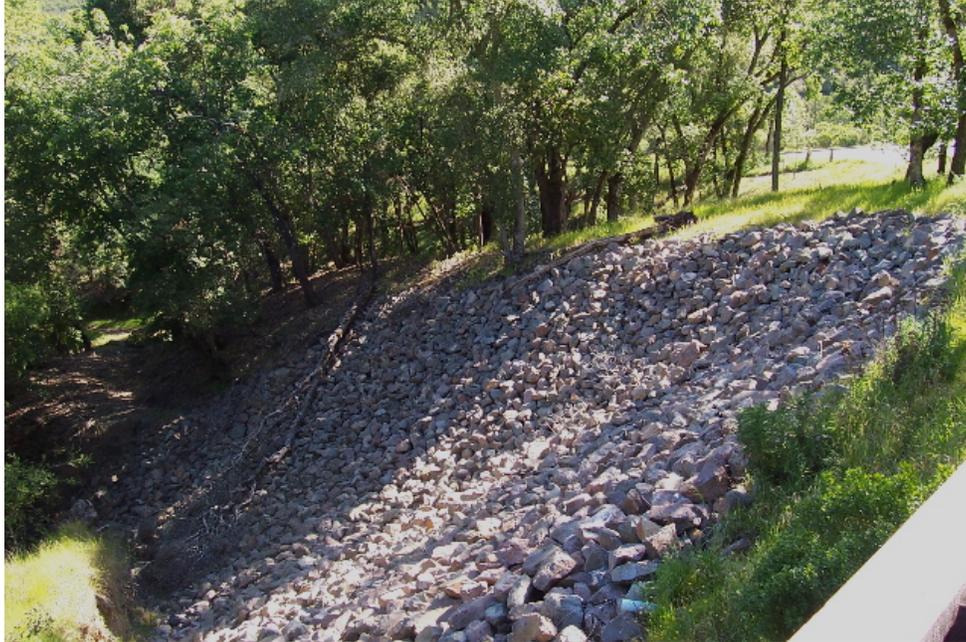
Figure 12. Slope protection applied to unstable area along access road, Blue Oaks subdivision, Portola Valley.

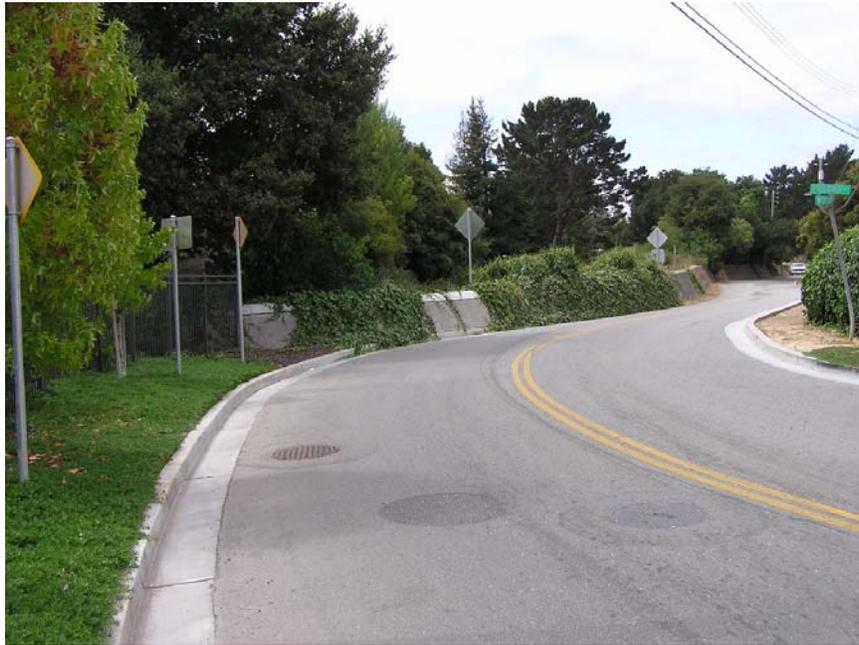
Figure 13. Floodwall along San Francisquito Creek, East Palo Alto.

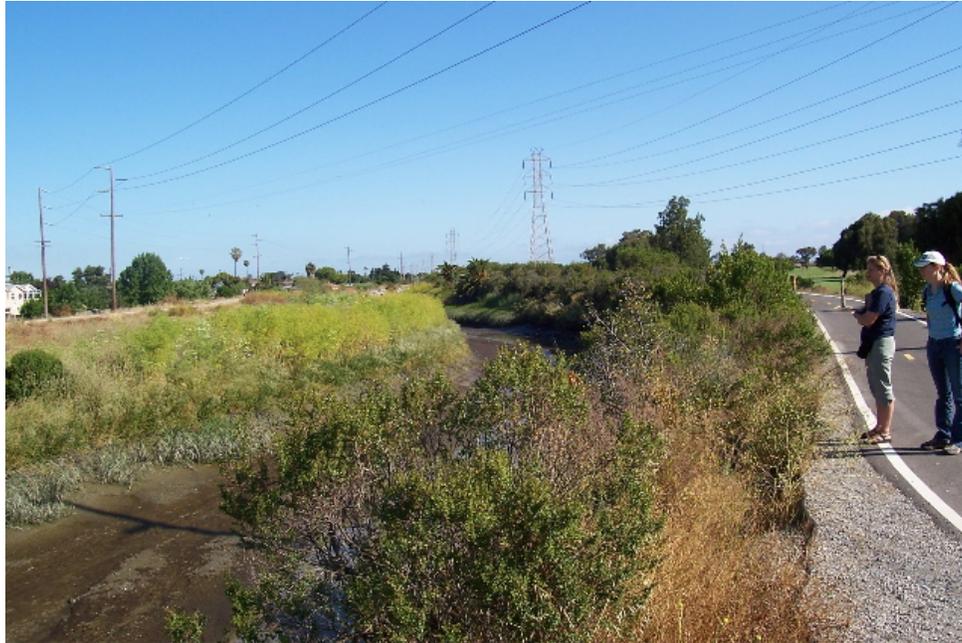
The planning and execution of this project clearly demonstrate a concern for anadromous fish and their habitats. Inspection of the project site after completion revealed no evidence of significant environmental impacts on either the stream or associated riparian vegetation (Figure 14).

Figure 14. Levee on San Francisquito Creek, downstream from Highway 101. Raising the levee had minimal effect on riparian vegetation or instream habitat. Note retaining wall to left of maintenance road that was used to raise the height.

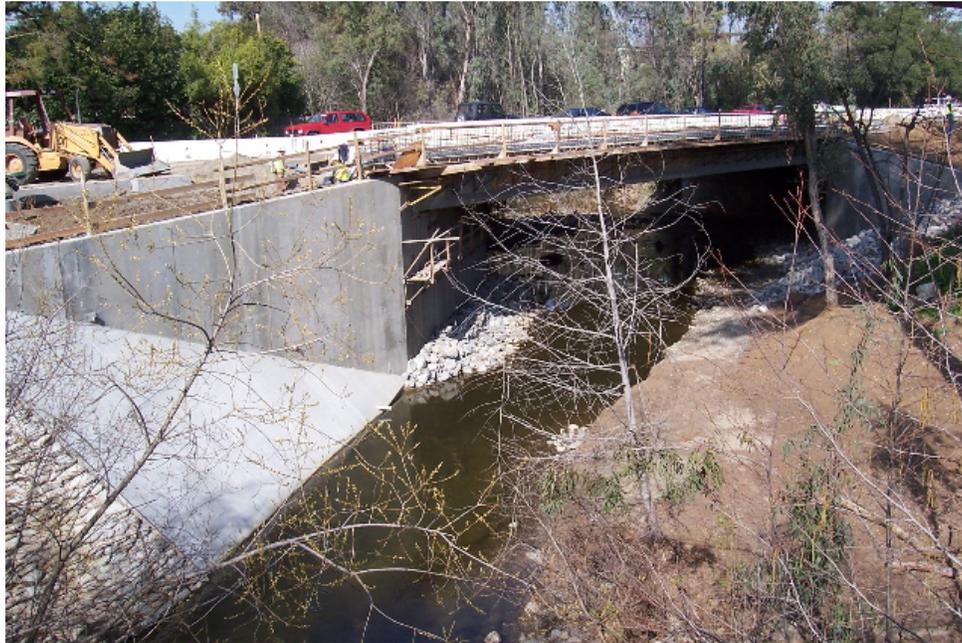
third of an acre of riparian vegetation was removed to enable construction (p. 4.7-52). The new road alignment was initially proposed to be within 60 feet of the creek (p. 4.7-53) but was subsequently moved to be at least 100 feet from the creek. Most disturbance stemmed from construction within the streambed. Also, permanent habitat changes occurred because banks were armored to prevent undermining of the structure. The banks had been armored with sacked concrete before the project, however, so this was an incremental change rather than an entirely new impact (Figure 15).

Figure 15. Re-constructed bridge on Sand Hill Road over San Francisquito Creek.

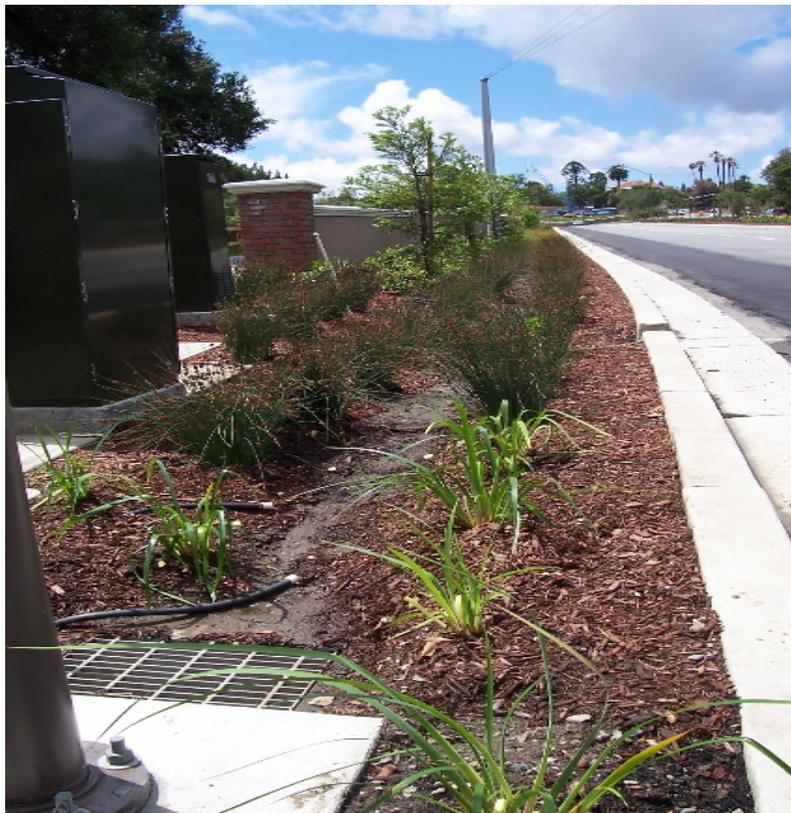
- Use of innovative storm drainage facilities including curb cuts to divert runoff to a vegetated swale before discharge to the creek (Figures 15 and 16).
- Requirement for the preparation and implementation of a Storm Water Pollution Prevention Plan to minimize construction-related water quality impacts.
- Requirement to minimize changes to the stream channel and to conduct hydraulic analysis of proposed changes to determine potential for downstream erosion.
- Restoration of channel bed and banks after construction and assurance that obstacles to steelhead migration were not created.
- Retaining a creek restoration specialist, hydrologist and arborist to oversee implementation of mitigation measures and riparian plantings.

Figure 16. Vegetated swale along Sand Hill Road. Road runoff is diverted to the swale through curb cuts (see Figure 17). The swale drains to a catch basin before entering San Francisquito Creek.

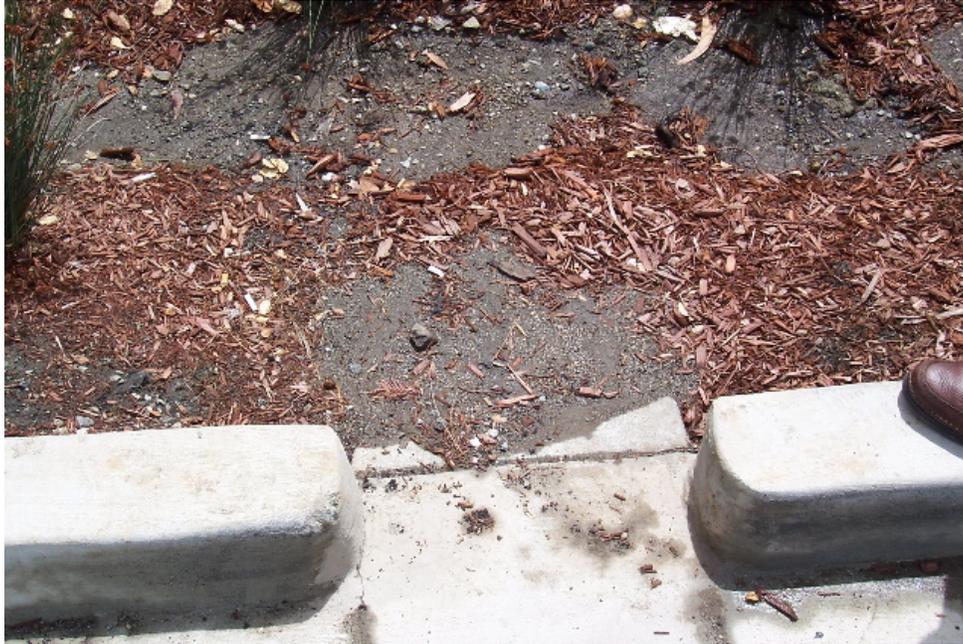
Figure 17. Curb cut in Sand Hill Road.

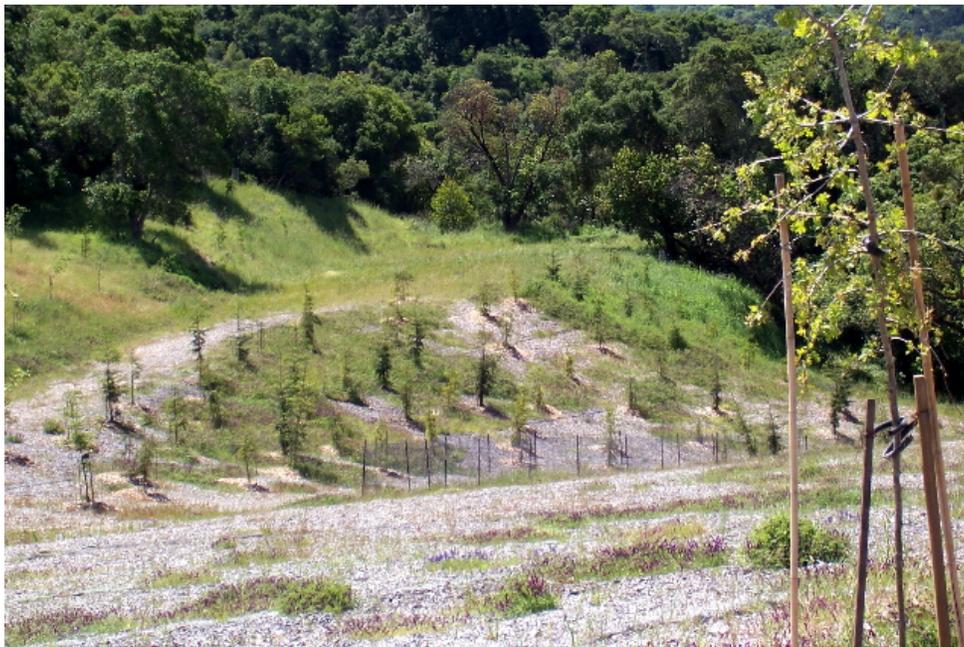
Figure 18. Building site and re-vegetation of graded area on Los Trancos Road subdivision (May 2005).

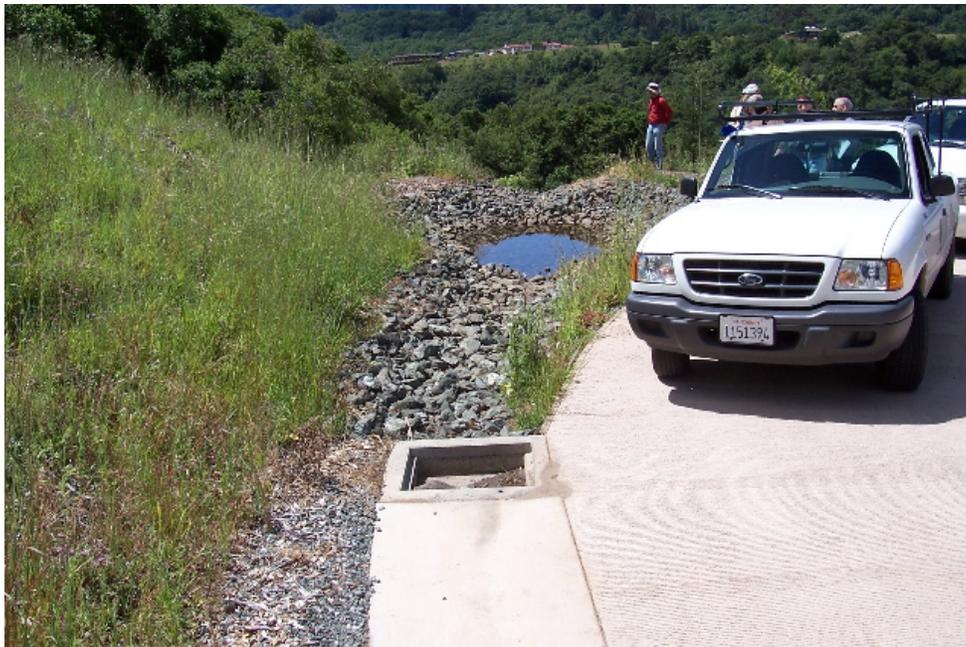
Figure 19. Sediment trap along access road to Los Trancos Road subdivision.

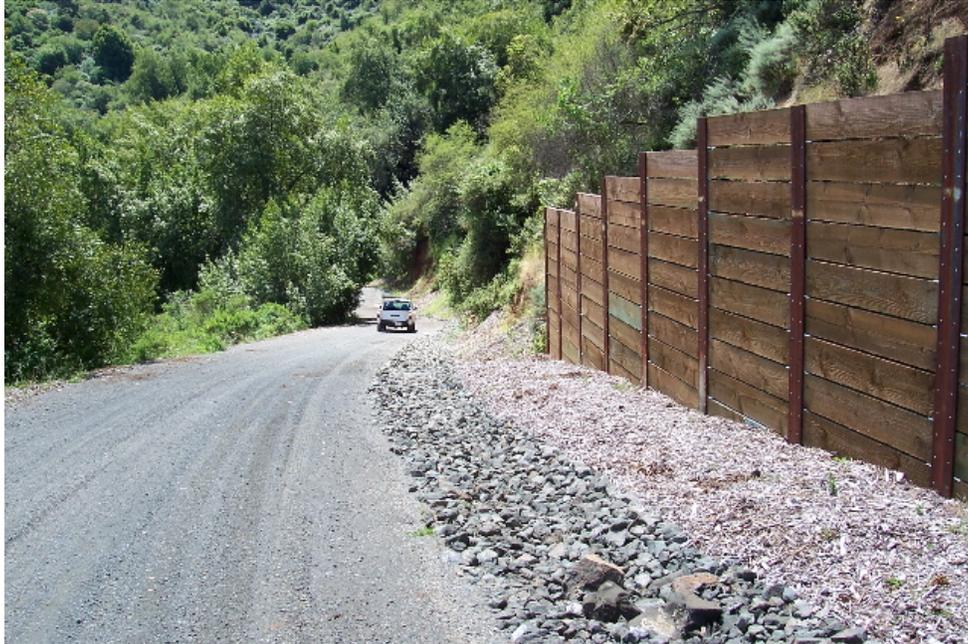
Figure 20. Rock-lined inboard ditch along emergency access road, Los Trancos Road subdivision. This treatment pre-dated the subdivision.

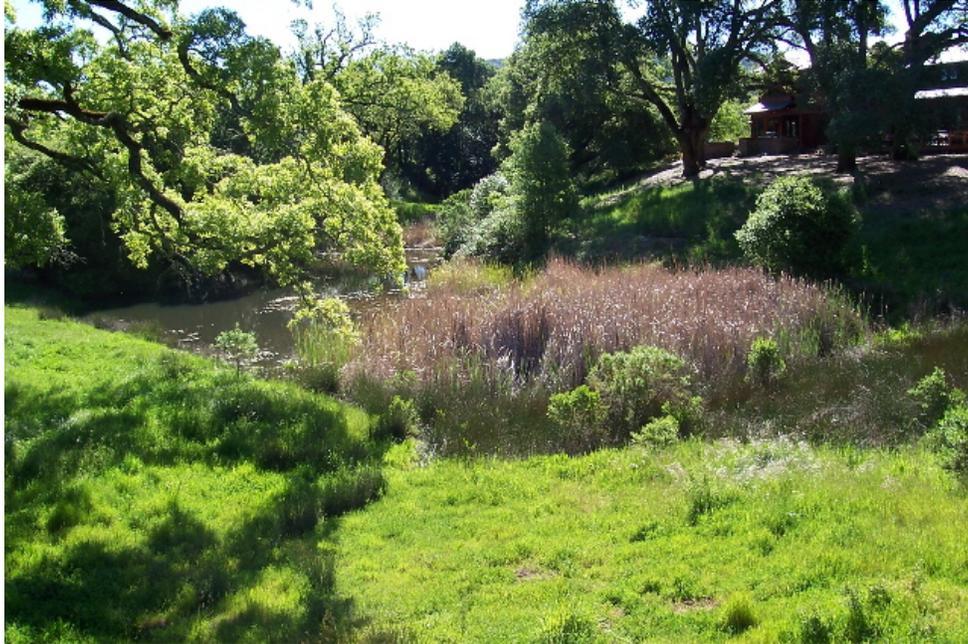
Figure 21. Recently constructed house and drainage control retention basin, Blue Oaks subdivision.

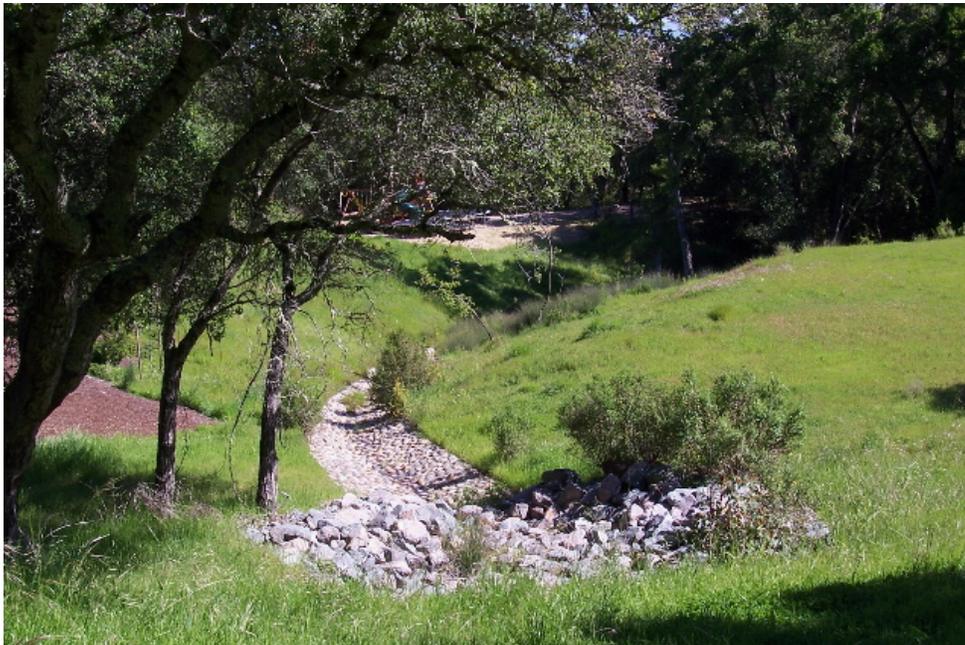
Figure 22. Rock-lined drainage swale, Blue Oaks subdivision.

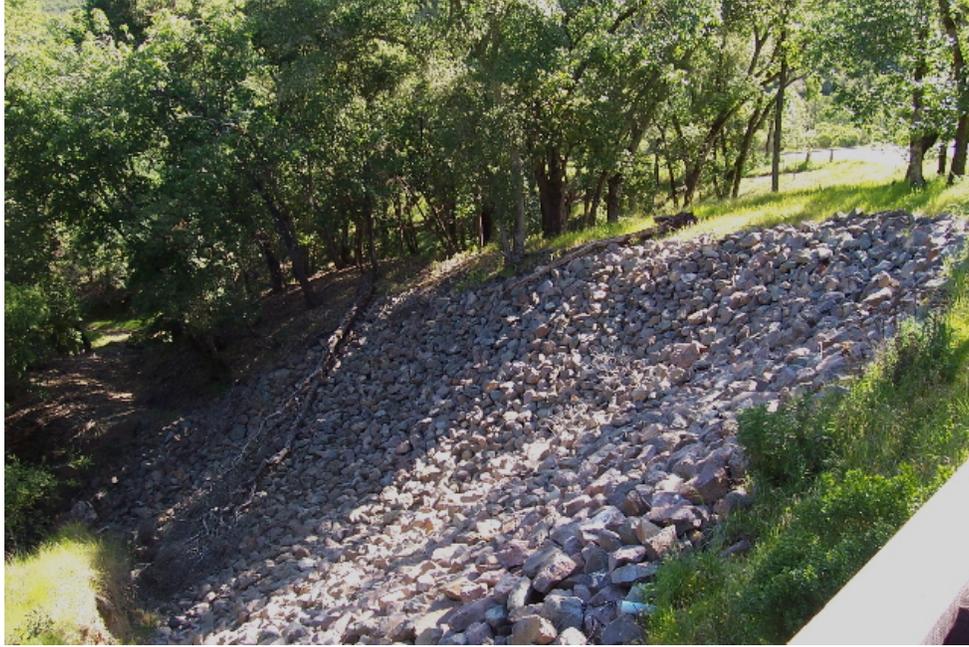
As was true for the Los Trancos Road subdivision, which is in the same area as Blue Oaks, the environmental review process for this project was detailed, prolonged and fruitful in terms of the end product obtained. There were no unavoidable significant impacts on either Los Trancos or Corte Madera Creeks identified. Some on-site drainage features were altered, primarily to enhance stability (Figure 22). In addition, measures were taken to reduce potential slope instability on slopes above channels (Figure 23).

Figure 23. Slope stability enhancement on access road to Blue Oaks subdivision.

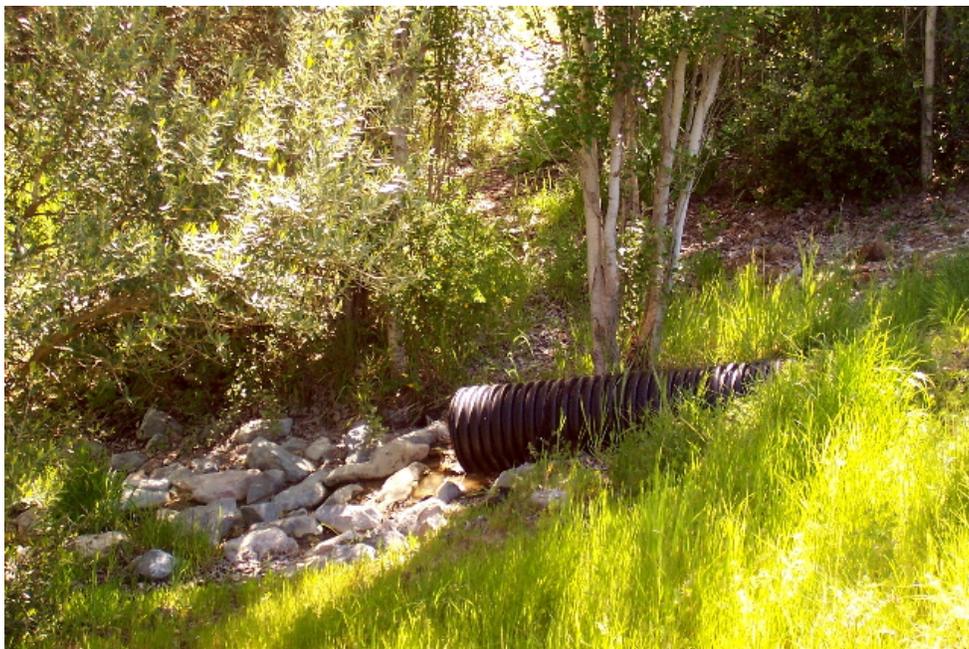
During construction, prescribed erosion control measures were implemented to ensure against sediment delivery to streams. These included the use of straw bales, straw rolls and immediate re-vegetation after grading. Culvert outfalls were armored to prevent development of gullies (Figure 24).

Figure 24. Armored outfall on cross drain, Blue Oaks subdivision.

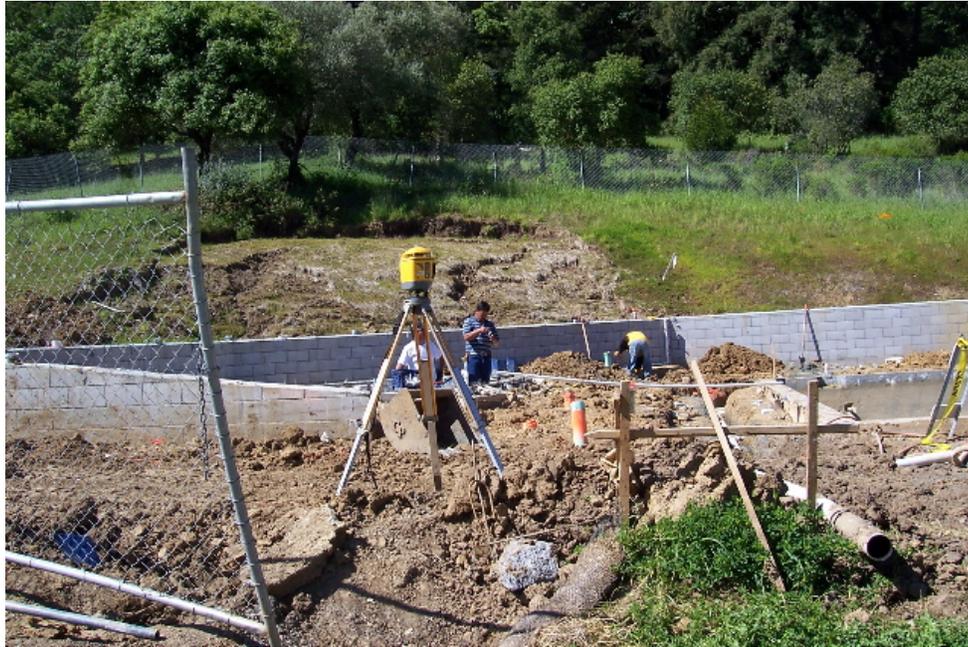
The only significant problem observed on the site was at a community facility construction site. Grading had initiated a landslide and remedial treatment will be required (Figure 23).

Figure 25. Slope instability at construction site, Blue Oaks subdivision.

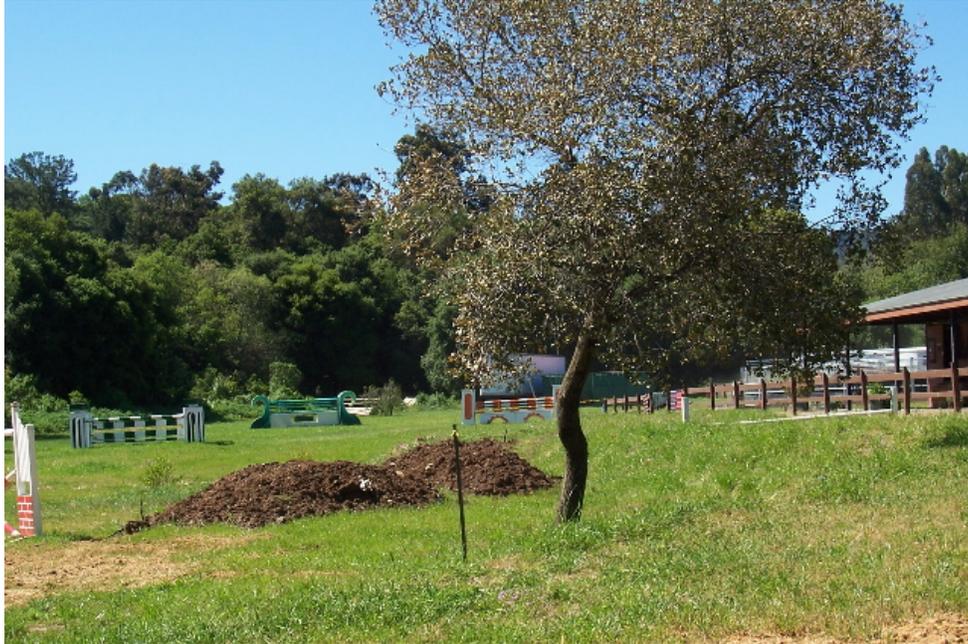
Figure 26. Glenoaks Equestrian Center.

All buildings and intensive use facilities are located at least 50 feet from Los Trancos Creek. The jumping area shown next to the riparian zone is used only occasionally.

The chronology for this project indicated that over four years were required to reach a result satisfactory to the Town. The numerous comments by Town staff and Planning Commission members with respect to impacts on Los Trancos Creek demonstrate a concern for the resource. The final product, as observed in the field, indicated that no significant impacts on Los Trancos Creek occurred during construction or subsequent use (Figure 26).

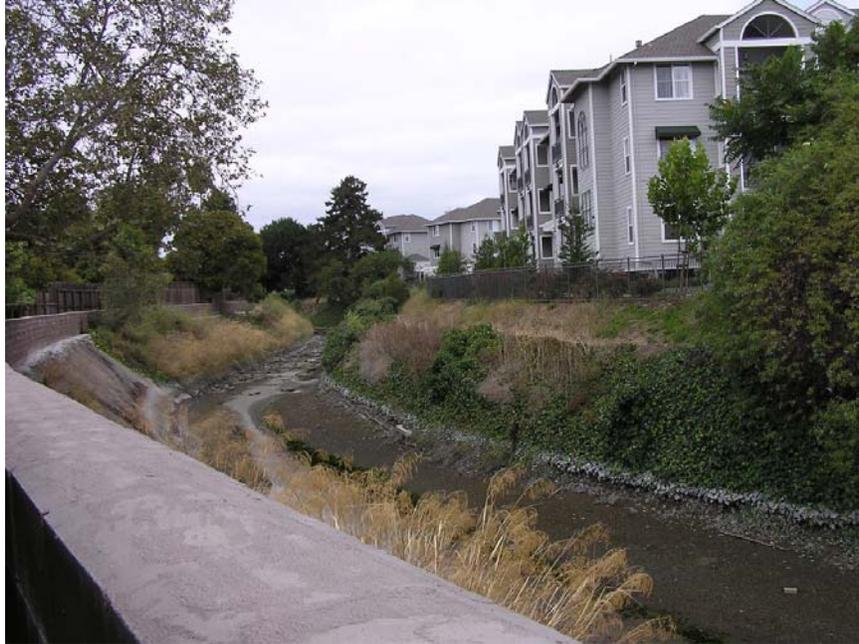
Figure 27. Woodland Creek Apartments, East Palo Alto.
Showing location of structures relative to San Francisquito Creek and floodwall.

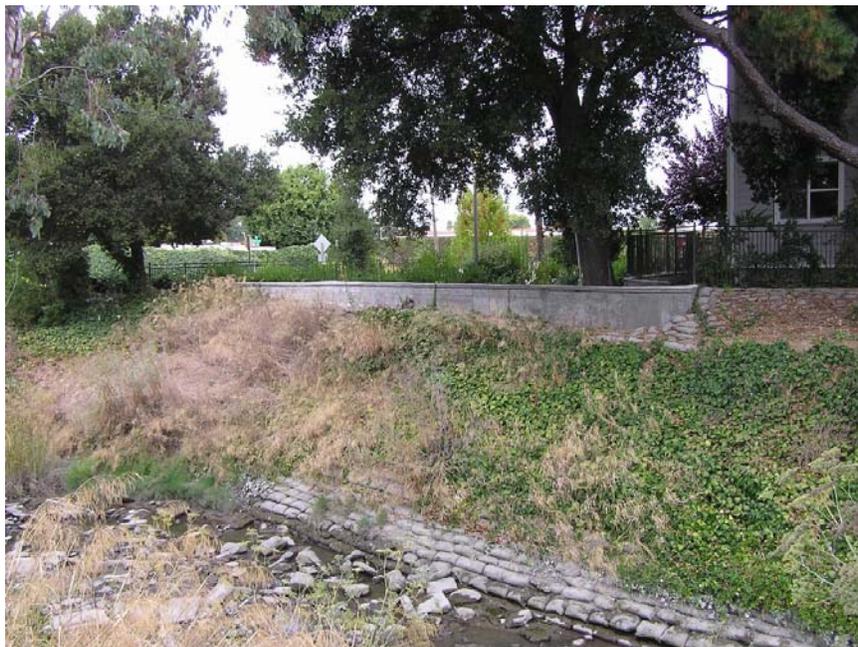
In an attempt to mitigate flooding both on and off the site, building elevations were raised above the 100-year flood level, a flood-wall was constructed along the creek at the top of the bank and a flow-through path through the project site for floodwaters was created. The flow-through provisions were apparently not implemented (Figure 28). According to SCVWD, despite these measures, there could still be an aggravation of off-site flooding during major events due to the project (B. Springer, personal communication). To this day, the flooding issue has not been resolved.

Figure 28. Woodland Creek Apartments. Showing location of proposed flow-through path designed to accommodate increased runoff from the project. The wall in the center of the photograph will prevent a flow-through path from functioning during high flows,

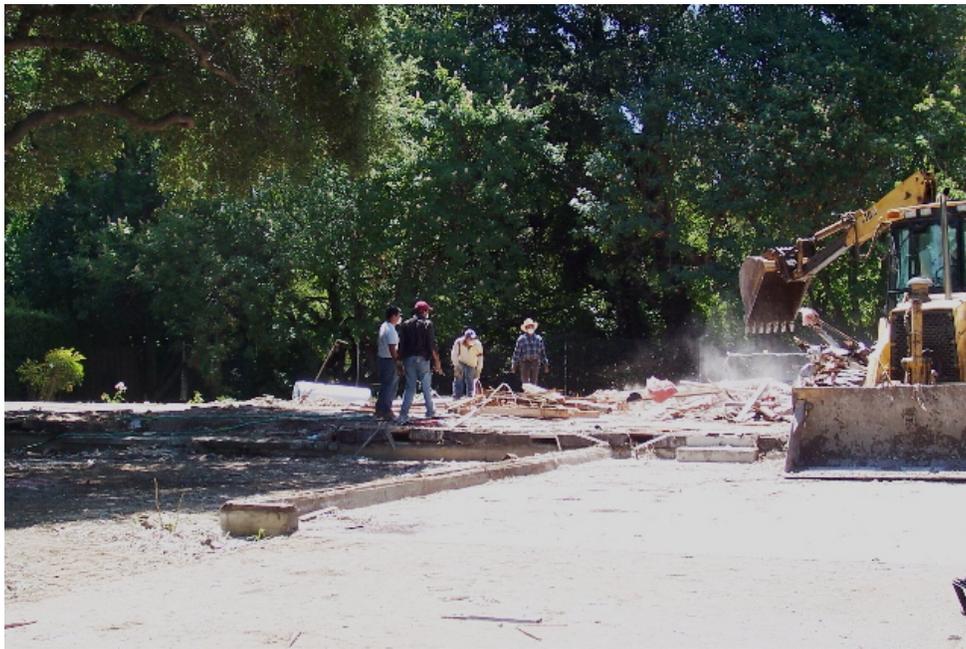
Figure 29. Demolition of single-family residence in riparian zone of San Francisquito Creek.

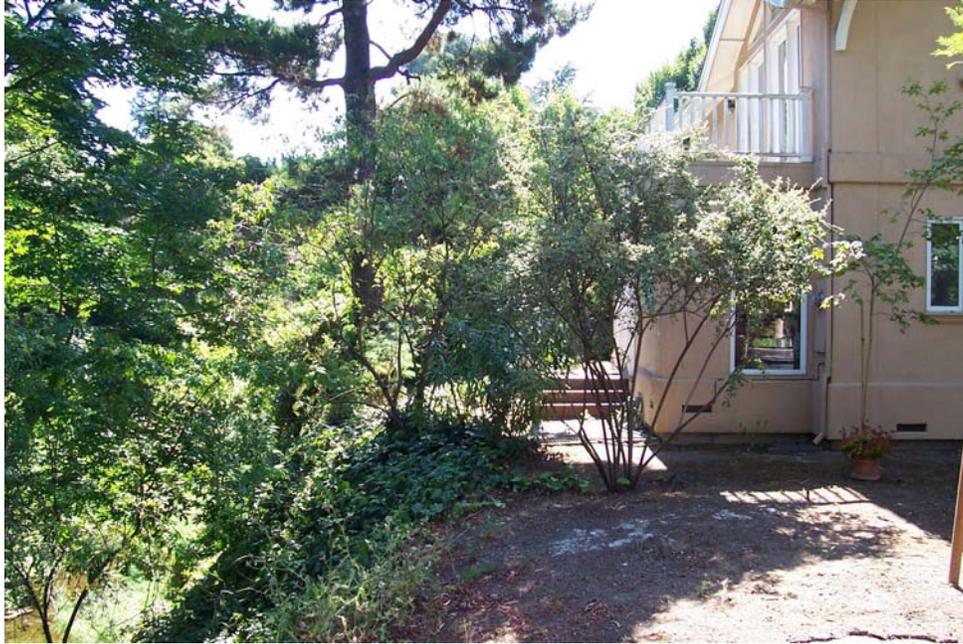
There were no consistently applied mitigation measures. Restrictions on construction in the vicinity of streams were not evident (Figure 30). In some instances, measures to prevent storm water pollution and urban runoff, such as permeable paving materials and downspouts leading to on-site retention features were observed. It is unknown if these were required as a condition of building permit approval or were voluntary measures. The jurisdictions involved generally require that impervious surface not be increased with a remodeling or re-construction project.

Figure 30. Single family residence adjacent to top of bank, San Francisquito Creek.
